PROJECT DETAILS

Purpose: Swimming pool

The Project

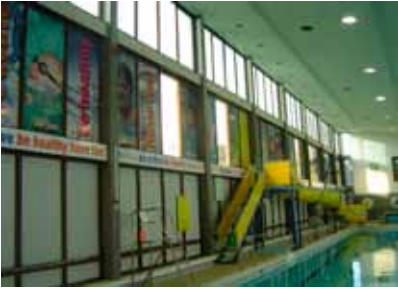
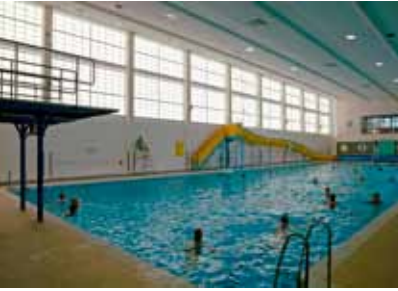
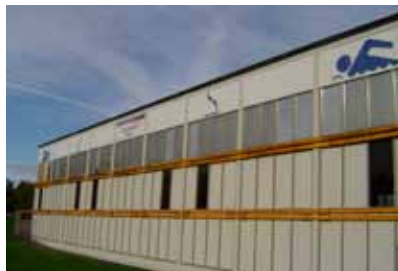
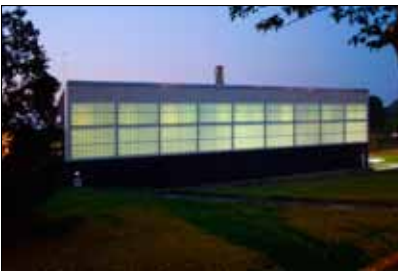
The agreed solution was to demolish the flank wall and rebuild in a different type of construction. Obviously, it was important to retain a large element of fenestration by installing a translucent system which would generate good daylight and also give protection against vandalism. Consequently it was the decision of Bradford MDC architects to rebuild using the Kalwall system. That decision was based on the architects' knowledge of Kalwall, particularly its reputation and widespread use on many new swimming pools, including some local authority pools which had also been refurbished. Consequently, Kalwall was installed over more than half the depth of the wall while the lower part was opaque and clad externally with terracotta tiles. At night, the pool presents a glowing exterior.

Bradford Metropolitan District Council and the public were delighted with the final refurbishment. The stunning effect of using Kalwall to diffuse natural daylight into the pool greatly improved the interior ambience. Running costs have been reduced because of the improved insulation and less reliance on artificial lighting. Another important observation is that the diffused daylight eliminates glare and veiling on the water which means that lifeguards can see swimmers better.

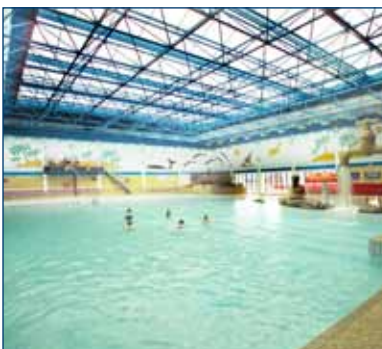
THIS POLYCARBONATE ROOF AT SHANKILL ROAD, BELFAST FAILED AND WAS REPLACED WITH KALWALL

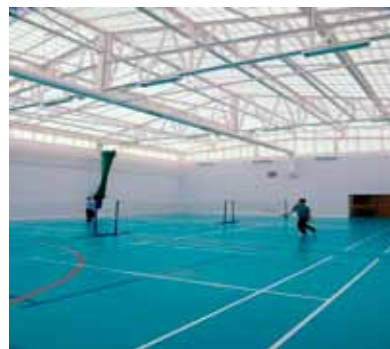
KALWALL REPLACED FAILED PATENT GLAZING AT SCOTLAND'S JOCK STEIN CENTRE CREATING IDEAL PLAYING CONDITIONS

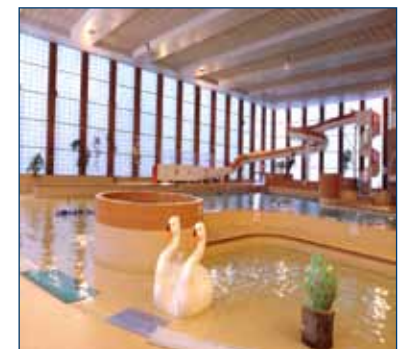
KALWALL SPARKLES BETWEEN BRICK PILLARS AFTER LETCHWORTH'S LOCAL AUTHORITY POOL REFURBISHMENT
